ANNIVERSARY WEEKEND RUNNING

The Missing Couplings!!

The “New” Locomotive

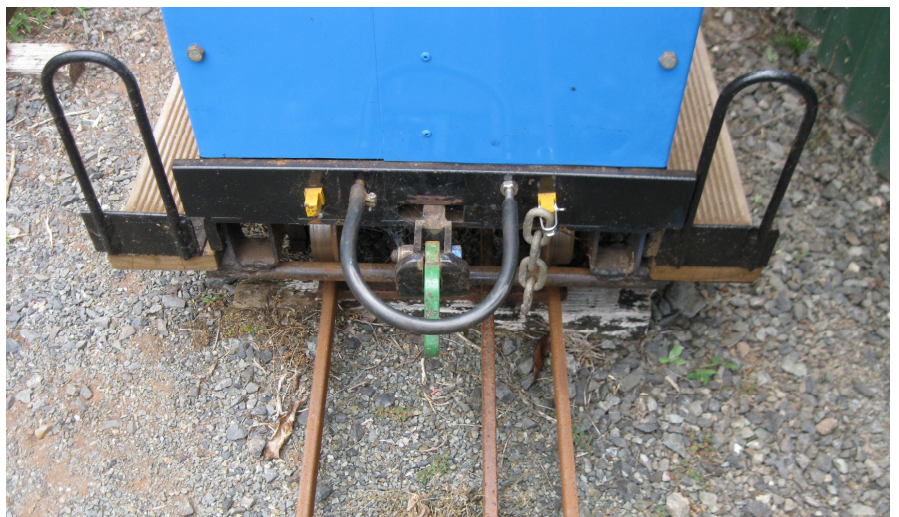
The brake hose on the trolley pictured has been blanked off as an end-of-train trolley. There should be a spigot on the headstock for this purpose. Also there are a few trollies that are not braked and there is a small sign fastened on the headstock to indicate this.

The rear of each trolley and/or engine should have a kidney link permanently fastened to the yoke of the coupling of that engine/wagon. So therefore when you connect up to an extra trolley or complete a consist there should be **NO** kidney link on the end of that item.

If there is, then someone has been playing silly buggers and that link should be removed — **NOT** the one on the rear of your train. The coupling on the end of wagon facing you should only have a clevis pin and a retaining clip to stop the pin from dropping out.

A few of the kidney links are stepped to allow for some variation of trolley height.

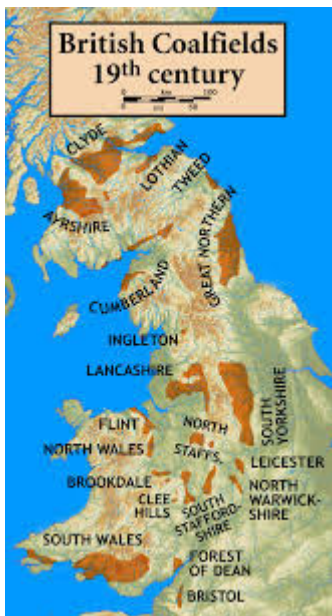
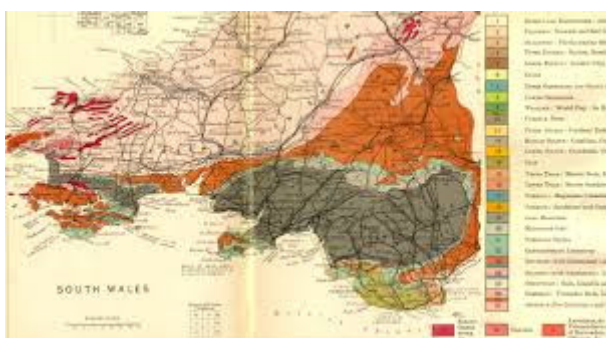
The maps on the left show the huge coalfields that existed in and around Wales and Scotland in the 19th Century. Most of these mines have now gone and coal is being imported into the UK from Europe and even India and Indonesia.

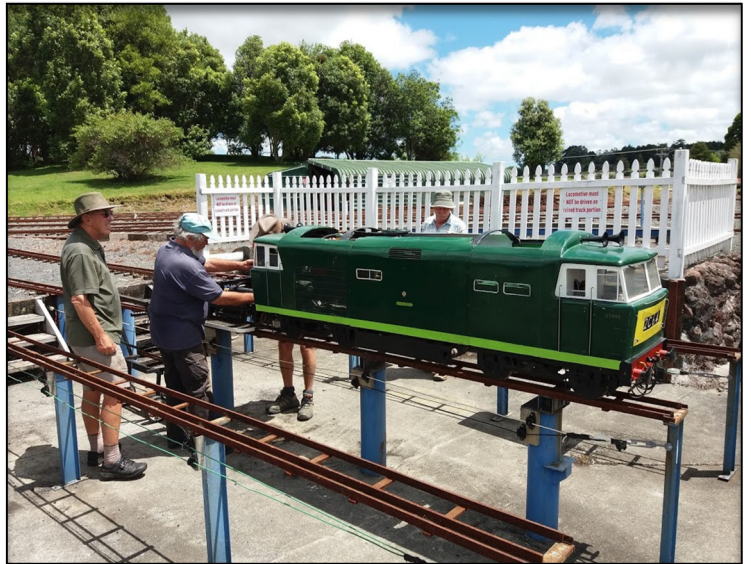
The loco being given an initial look-over upon arrival at Maunu.

John built it from scratch to fit a certain size road trailer he had.

This trailer was a little short on length so the loco was built to fit and this gave it a short, stubby look.

John decided that it didn't really look right so he obtained another trailer and lengthened the engine by about 25%. And this alteration made it look quite handsome.

The power-plant is a 3-cylinder petrol 1960 Daihatsu auto engine rated at about 10.3 horsepower.

As per the original it also has hydraulic transmission.

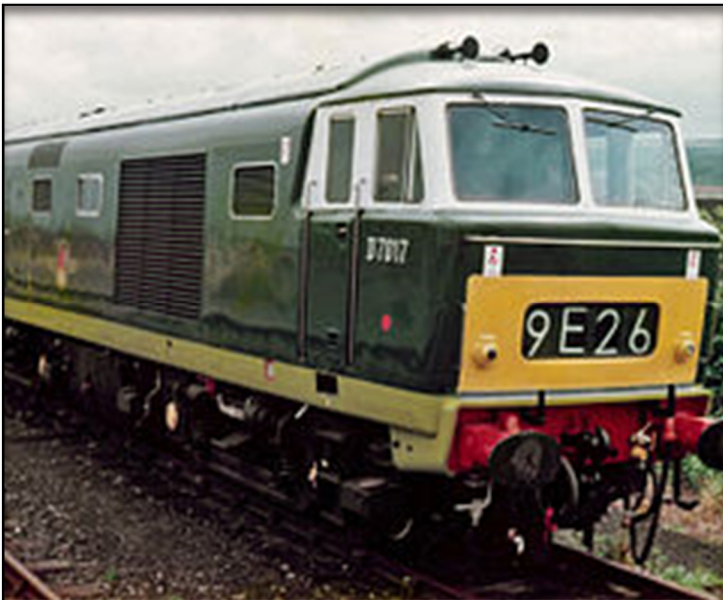
A picture of the real McKoy

ORIGINAL BR CLASSIFICATION HYMEK CLASS 35

Road Numbers: D7000 - D7100.

Built by Beyer Peacock (Manchester) 1961– 1965.

Wheel Arrangement: B - B.

Operational Weight: 74 tons.

Maximum Speed: 90 m.p.h.

Engine: Maybach MD870.

Horsepower: 1740.

Tractive Effort: 46,600lbs.

Transmission: Mekydro K 184V.

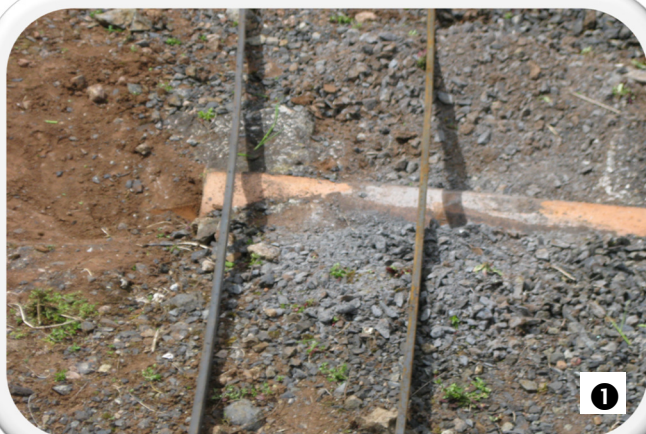
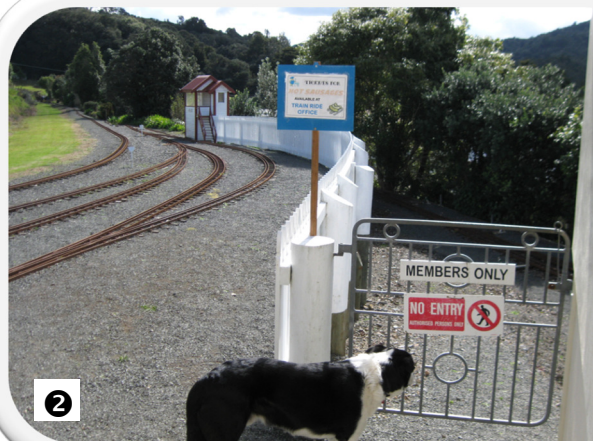
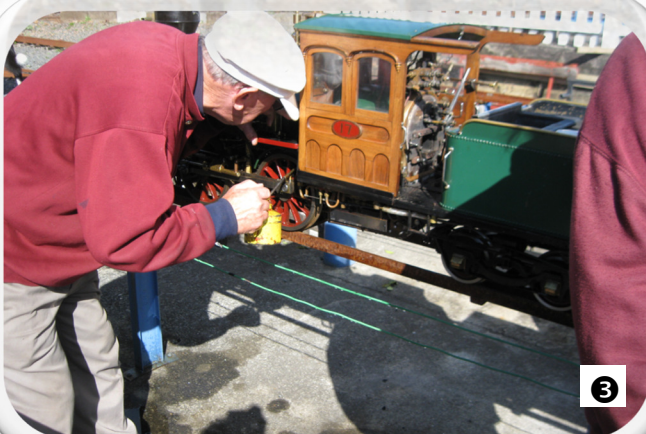
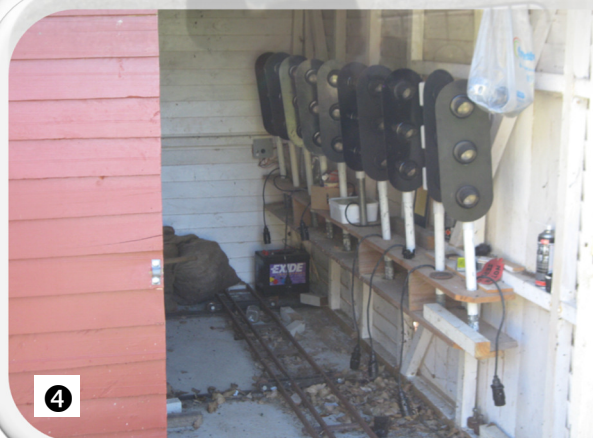
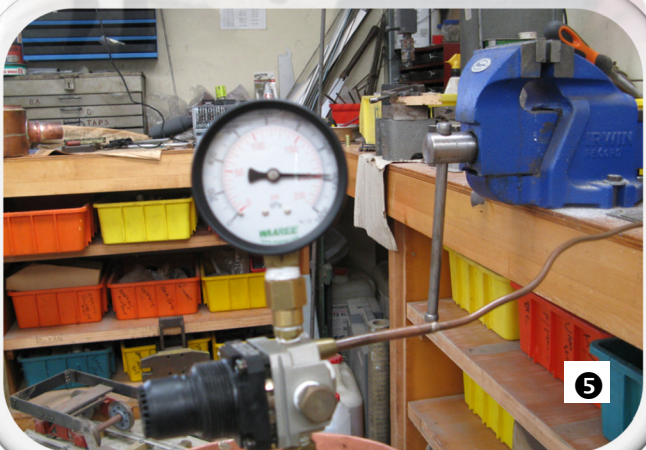
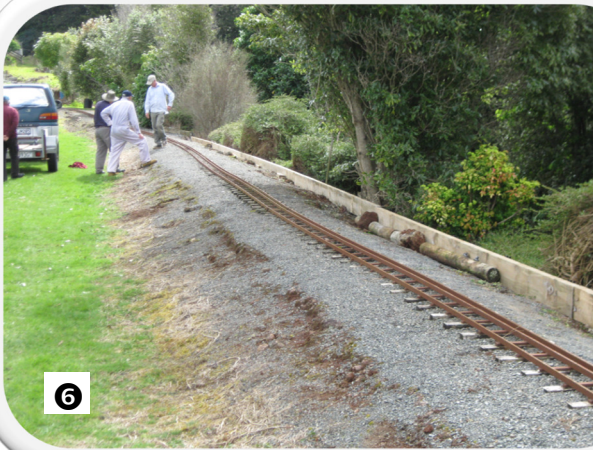
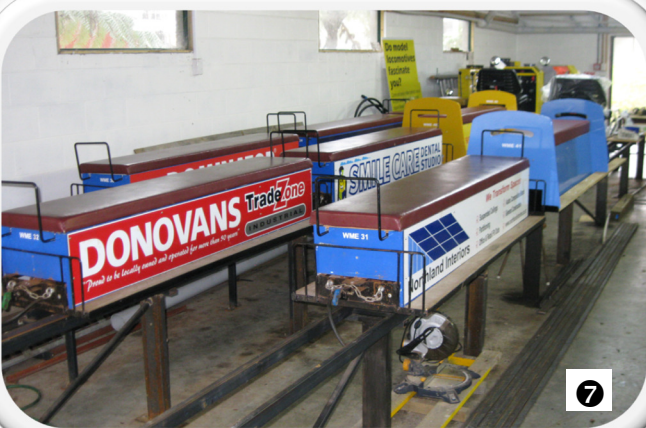
PHOTOS ABOVE:

- 1 Relaying track and drainage behind the mountain.
2. The dog don't look too happy 'cause there's a gate in his way.
3. Rankin getting his loco ready for running.
4. The signal storage shed.
5. Newly calibrated pressure test gauge for our boiler test-bed
6. Work going on re-aligning track to tunnel entrance.
7. Under the clubhouse. Two tracks on left with trains ready to go. Other track is the Sick Bay.
